2011
**WATER
QUALITY**
annual report

This report summarizes the 2011 water quality monitoring and testing by the City of Moncton utility staff for the Moncton/Riverview/Dieppe service area and outlines various initiatives designed for long term sustainability of the water supply and delivery system.

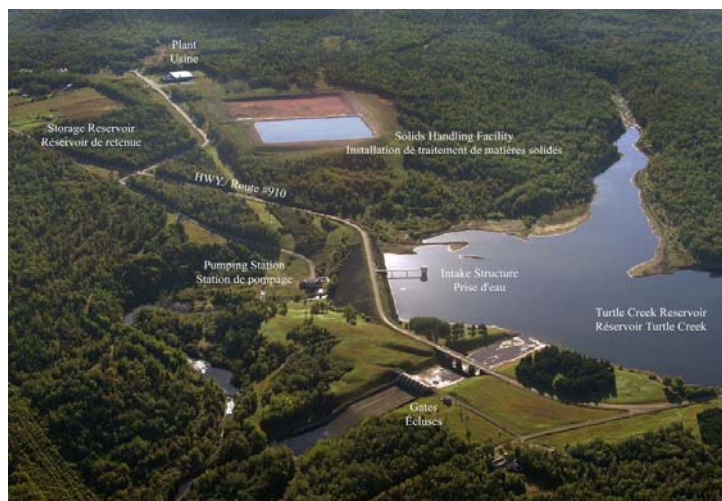
Figure 3: Aerial view of the Turtle Creek Reservoir

During 2011, the Turtle Creek Reservoir supplied an average of 49,000 cubic metres (10.8 million imperial gallons) of water per day to the tri-community.

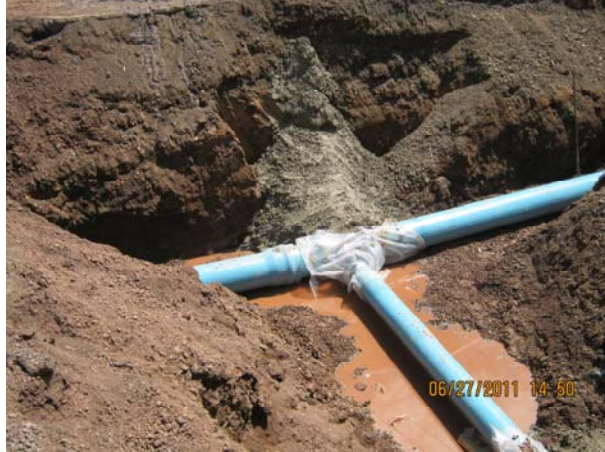
Figure 7: Watermain Tee Connection

In 2011, the City of Moncton renewed approx. 3.6 km of existing watermain, including mains on Killam Drive, Lewisville Road, Milner Road, Royal Road, Ellerdale Avenue, West Lane and Rockland Drive.

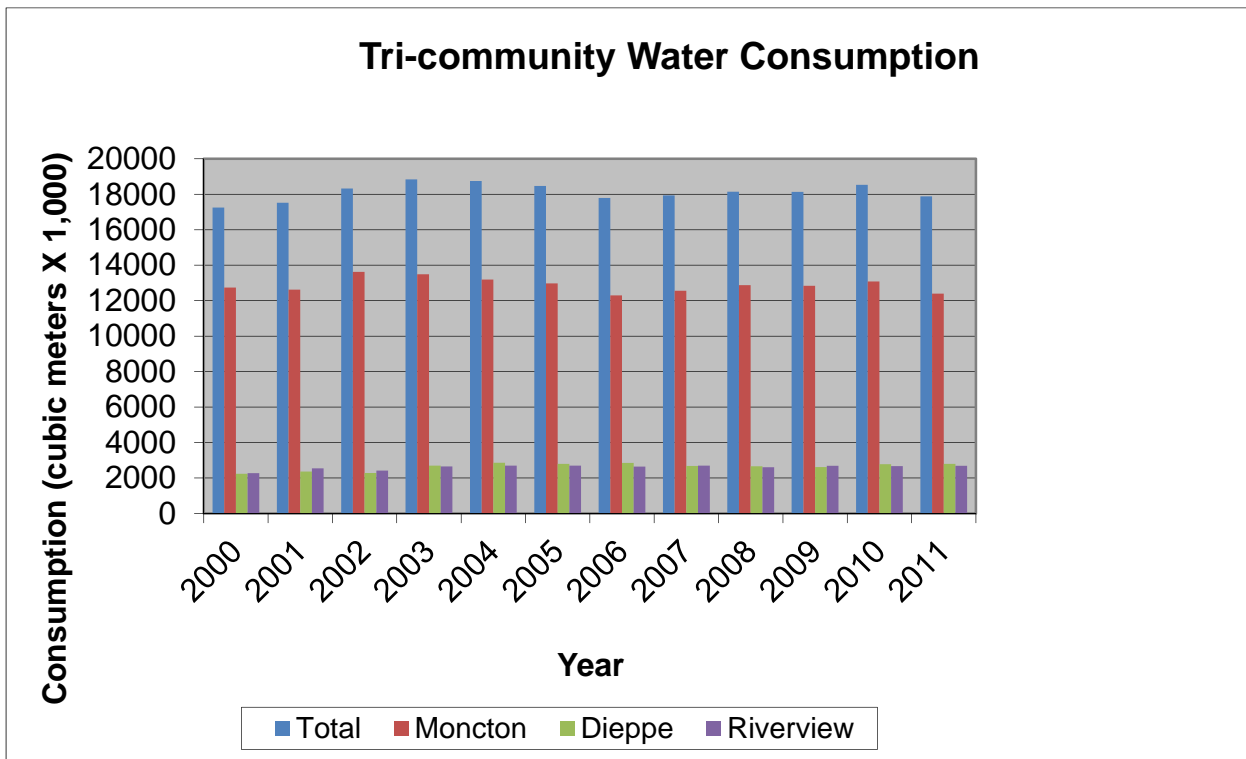
Figure 8: Tri-Community Water Consumption

Despite population growth, the tri-community has been able to keep water consumptions from increasing due to various water conservation programs.

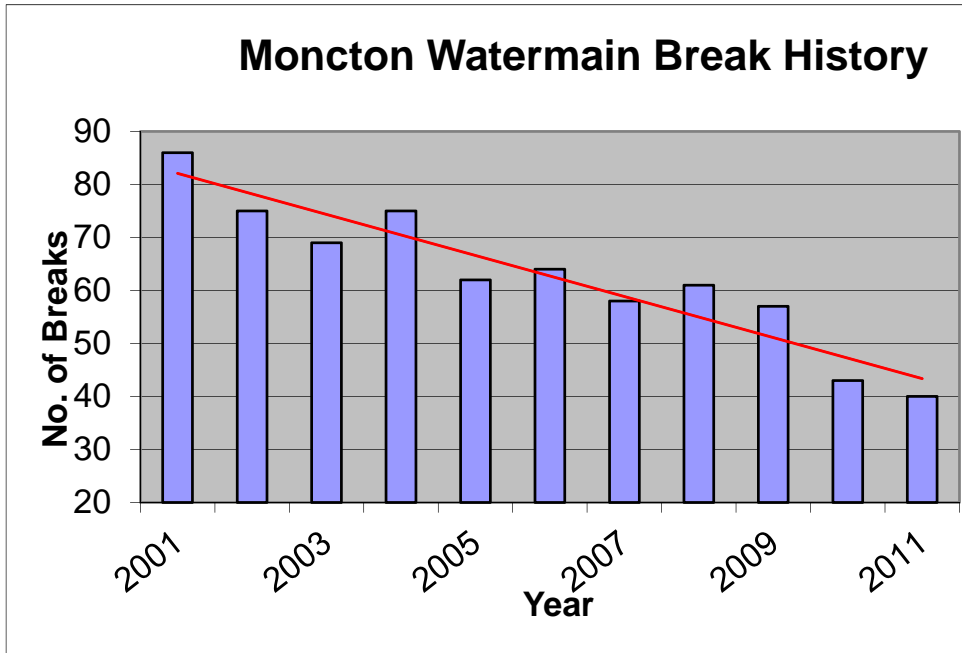
Figure 9: Watermain Break History

Over the past number of years, Moncton has accelerated its watermain replacement program by replacing “high break frequency” mains. The charts below show the history of annual number of watermain and water service breaks/leaks. These illustrate the effectiveness of the city’s watermain replacement/rehabilitation program.

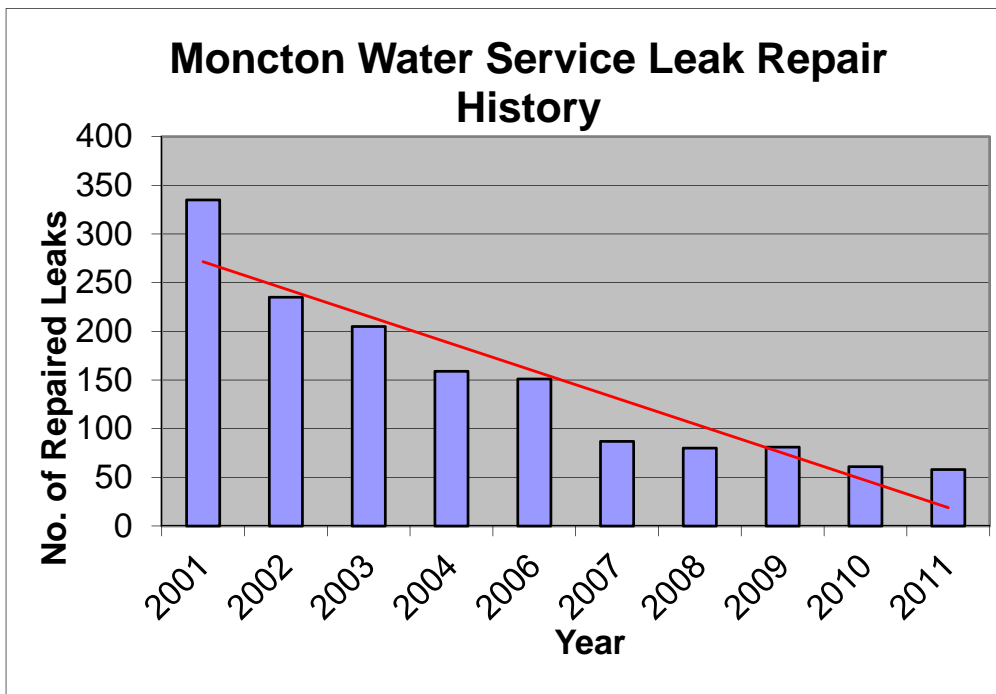
Figure 10: Water Service Leak History
